Manly Lagoon: Review of environmental processes

WRL TR 2021/23, October 2022

Report title	Manly Lagoon: Review of Environmental Processes
Authors(s)	T A Tucker, D S Rayner and A J Harrison
Report no.	2021/23
Report status	Final draft
Date of issue	October 2022
WRL project no.	2020060
Project manager	T A Tucker
Client	Northern Beaches Council
Client address	55 Middleton Road Cromer NSW 2099
Client contact	Jason Ruszczyk Jason.Ruszczyk@northernbeaches.nsw.gov.au
Client reference	#

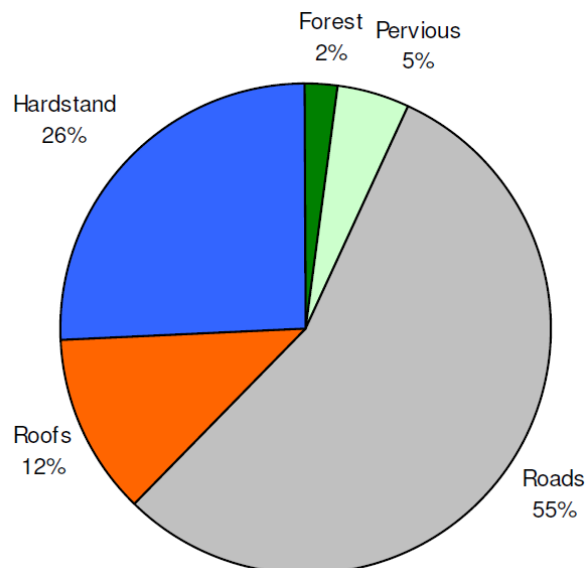
catchment hydrology behaviour as impervious developed surfaces (e.g. roads or rooftops) are more likely to lead to quicker runoff times compared to the natural parts of the catchment and subsequently contribute higher loads of pollution. Figure 2.1 shows that despite making up approximately 55% of the catchment, areas characterised as having a high impervious percentage contribute the most (~93%) to sediment loading.

Figure 2.1: Total sediment loads for different land use types (McManus and Knights, 2011)

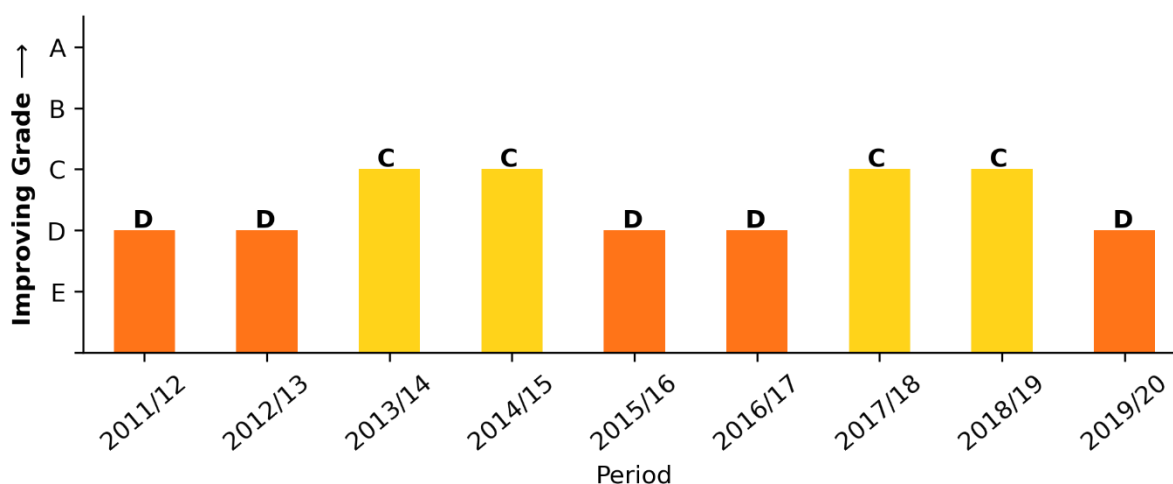
Roper et al., (2011) developed default guideline for turbidity and chlorophyll-a using the 80th percentile values for data collected for reference estuaries within NSW. Comparison of water quality measurements sampled within Manly Lagoon to these trigger values gives the lagoon an overall grade of poor to fair (Figure 2.2). Further details regarding this grading can be found in Appendix A.

Figure 3.2: Grading of Manly Lagoon using trigger values developed by Roper et al. (2011) for NSW Estuaries (see Appendix A for further details)

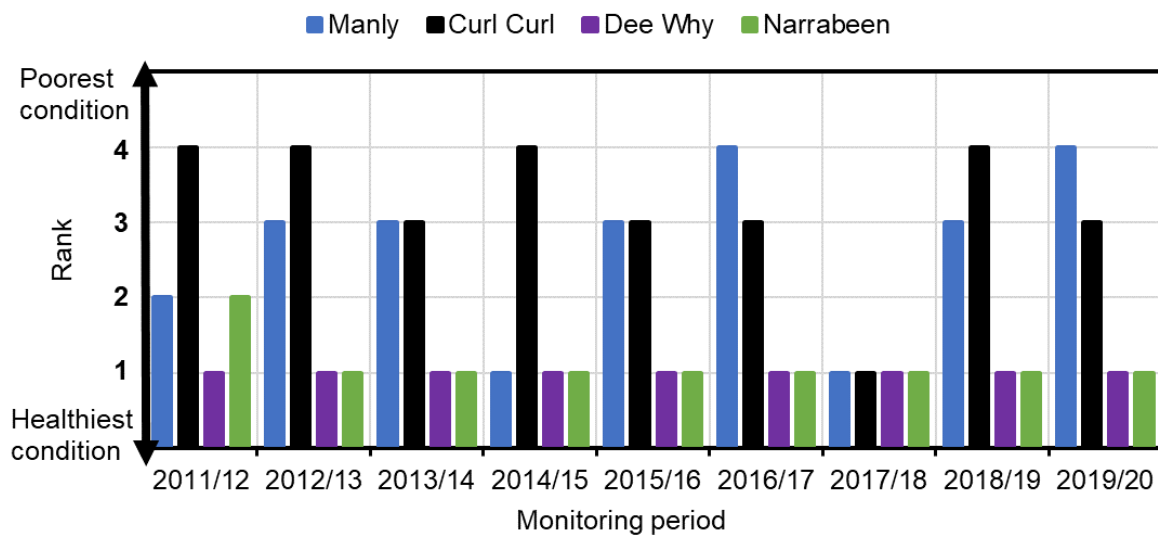
Each of these lagoons has been compared with Manly Lagoon in terms of eco-health using chlorophyll-a and turbidity data. The lagoons have then been ranked based upon which has the best or worst eco-health. Figure 3.3 shows that Dee Why and Narrabeen Lagoons are continually the healthiest on the Northern Beaches. Curl Curl Lagoon generally had the worst health of all the lagoons, however, Manly Lagoon has also been identified as having the worst health for a number of monitoring periods.

Figure 3.3: Ranking of eco-health for Northern Beaches estuaries

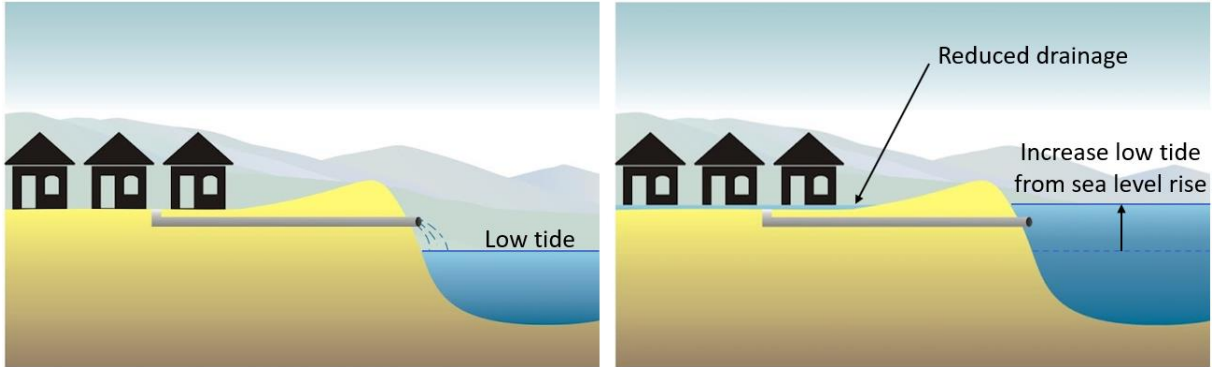
In addition to impacts associated with tidal inundation, sea level rise may cause reduced drainage across the Manly Lagoon floodplain. As sea level rise occurs, the low tide elevation will also increase. An

increased low-tide elevation will raise the level to which the stormwater system servicing the urban area around Manly Lagoon can drain (Figure 4.6). Increased inundation, whether from tidal inundation or reduced drainage, will require additional developments across the floodplain which may further impact the environment.

Figure 4.6: Potential mechanism for reduced drainage in urban areas caused by an increase in low-tide elevation due to sea level rise

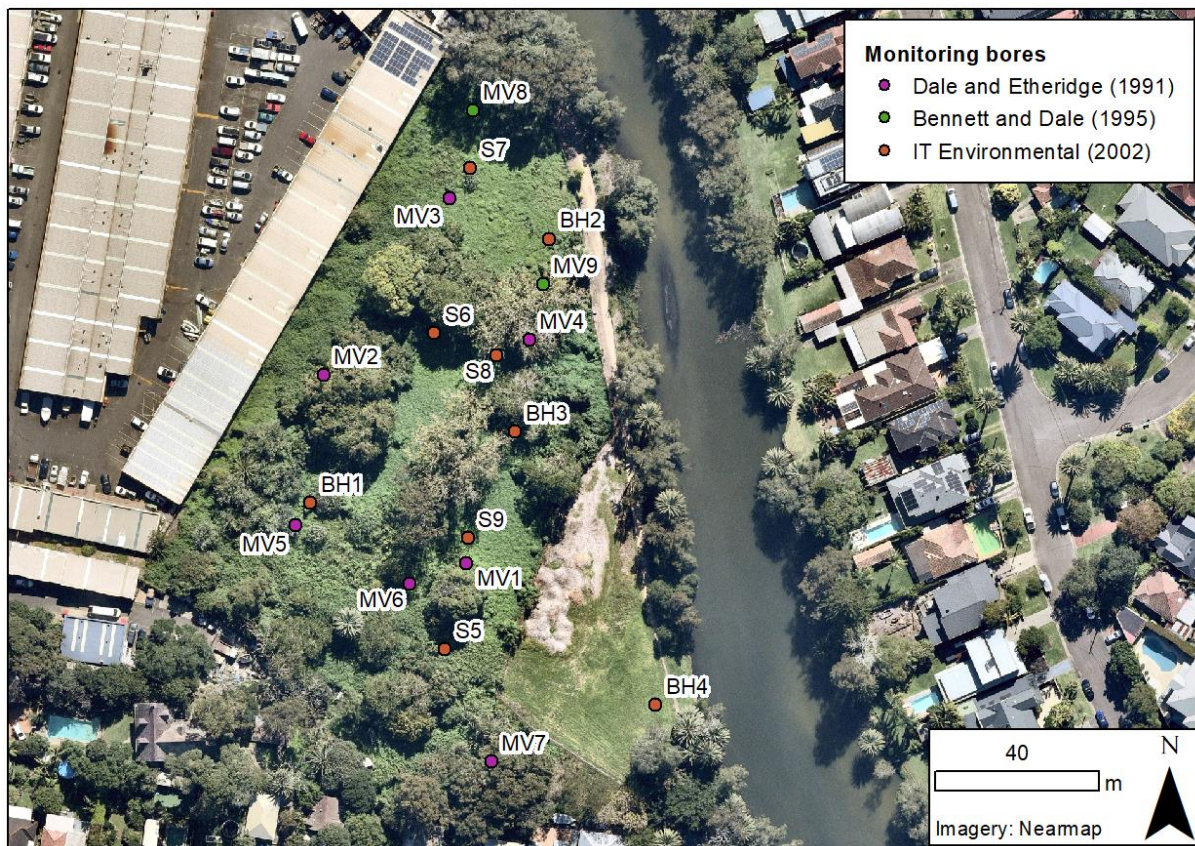
In 2008, Parsons Brinkerhoff (2008a; 2008b) reviewed the groundwater monitoring completed at the site over the previous decade for the development of a groundwater management plan and a remedial action plan. Upon reviewing the monitoring data they concluded that the primary contaminants of concern for the site are heavy metals (zinc, copper, cadmium and lead), PAHs, total petroleum hydrocarbons (TPHs), and ammonia. Of these they noted that zinc was consistently at higher concentrations than guideline values. Review of groundwater flow by Parsons Brinkerhoff (2008a; 2008b) found that there is a hydraulic gradient of approximately 0.005 m across the site with the groundwater flowing in an easterly to north-easterly direction.

A.2: Historic monitoring bores at the Addiscombe Road remediation site

A number of groundwater bores have been installed at a former landfill site located on the south bank of Manly Lagoon between Addiscombe Road and Campbell Parade (Figure A.2). Seven monitoring bores were constructed in 1991 as part of an environmental assessment for a proposed development at the site (Dale and Etheridge, 1991). In 1995 further two monitoring bores were constructed during the development of a remedial action plan for the site (Bennett and Dale, 1995). Monitoring of these bores found groundwater was contaminated with heavy metals (specifically zinc, copper, chromium and lead) (Bennett and Dale, 1995; Cambridge and Ross, 1997; W. S. Rooney, 1997). Of these heavy metals, zinc and copper were found to be above ANZECC (1992) guideline levels (Cambridge and Ross, 1997).

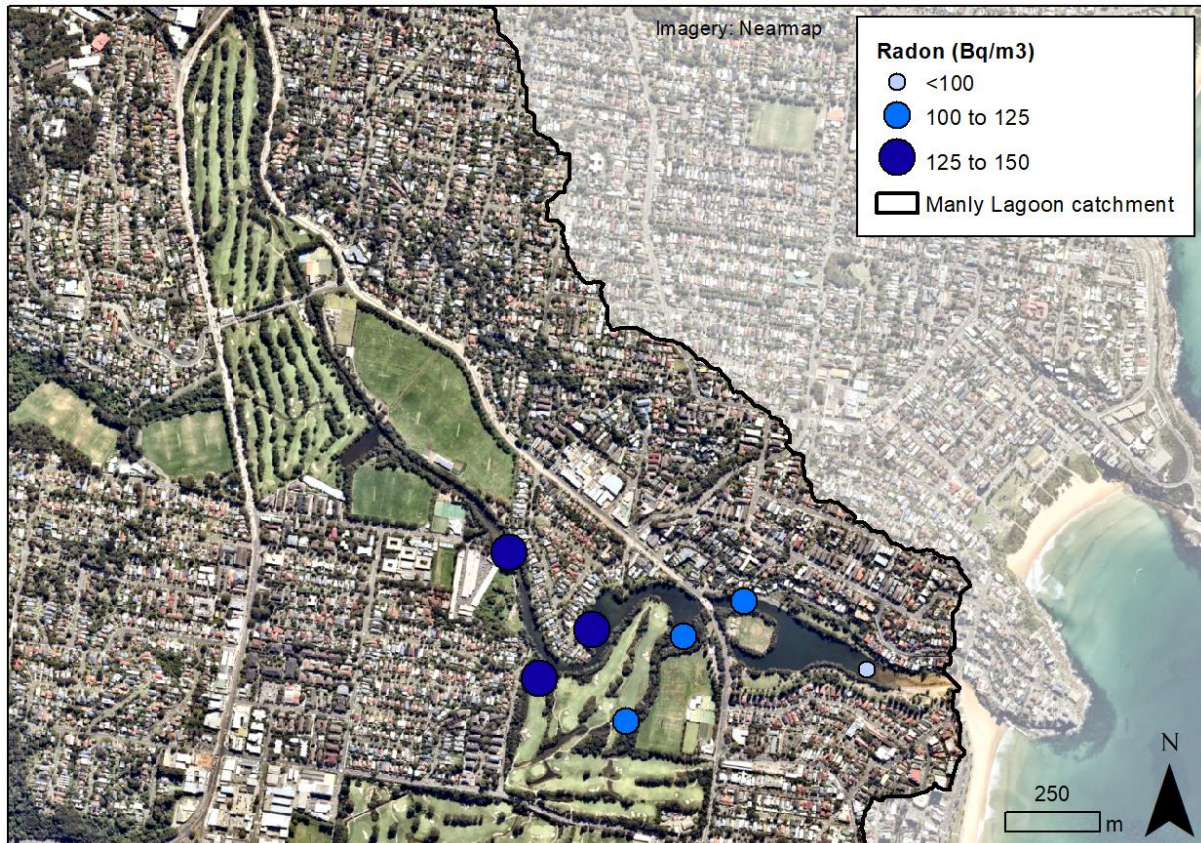
Radon measurements observed at different locations across the lagoon on 26 July 2016 are presented in Figure A.6. This clearly shows that there is a greater influence of groundwater in the lagoon further from its entrance with the ocean. It is likely this is caused from flushing at the entrance with ocean water which has a low radon concentration.

A.6: Radon measurements across Manly Lagoon on 26 July 2016

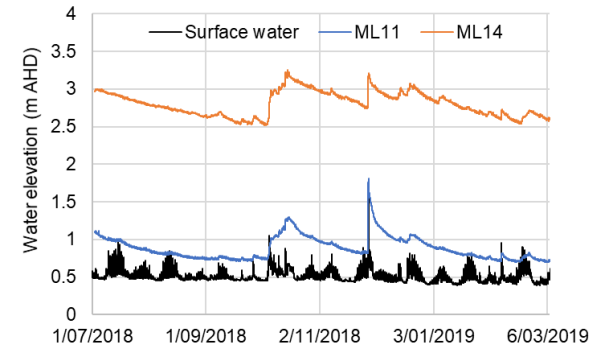
A.10: Comparison of groundwater and surface water levels (2018 to 2019)

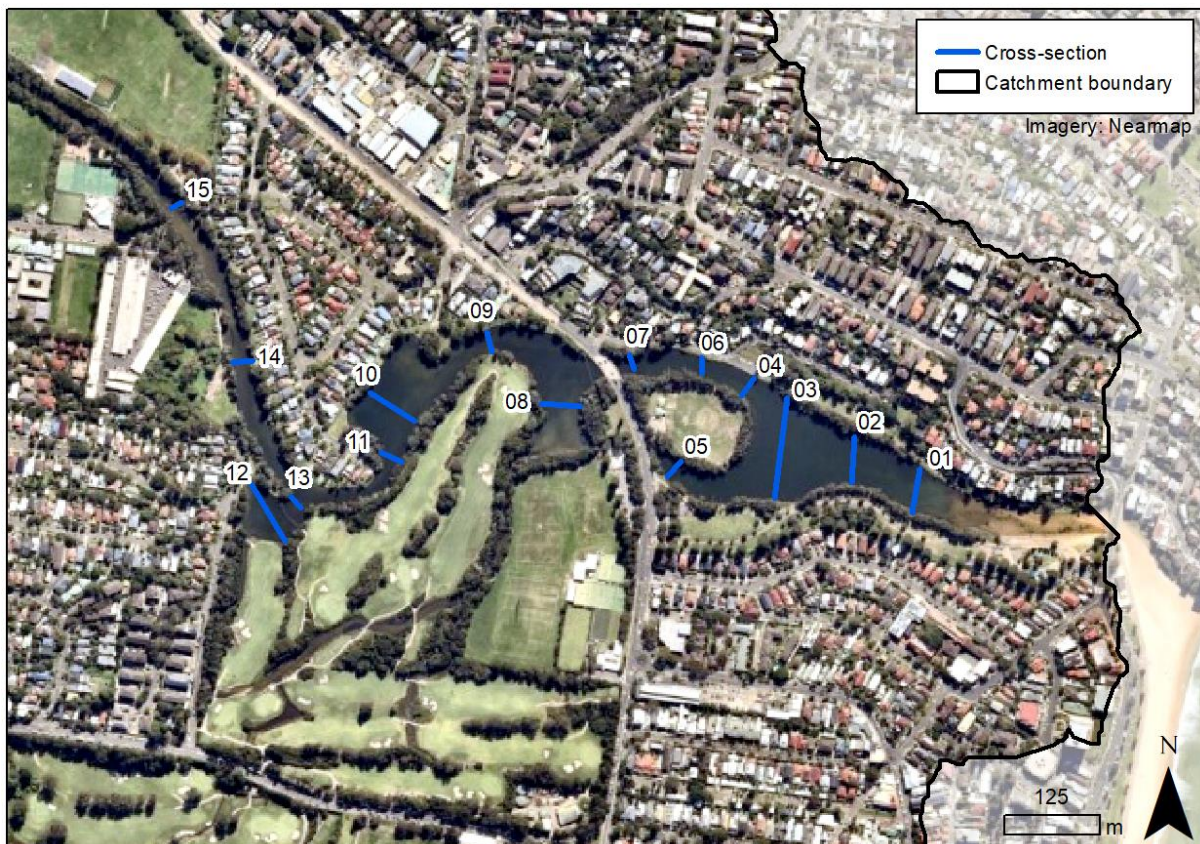
Bathymetry measured in 2011 has also been compared to recent measurements taken in 2017 by Harrison and Rayner (2019). Figure A.14 shows the cross-section locations where bathymetry data has been compared and Figure A.15 shows the comparisons between the two datasets. Note, measurements were gathered using an echosounder which can only take measurements underwater so the banks of the lagoon are not shown in Figure A.15.

A.14: Location of cross-sections where 2011 and 2017 data was compared

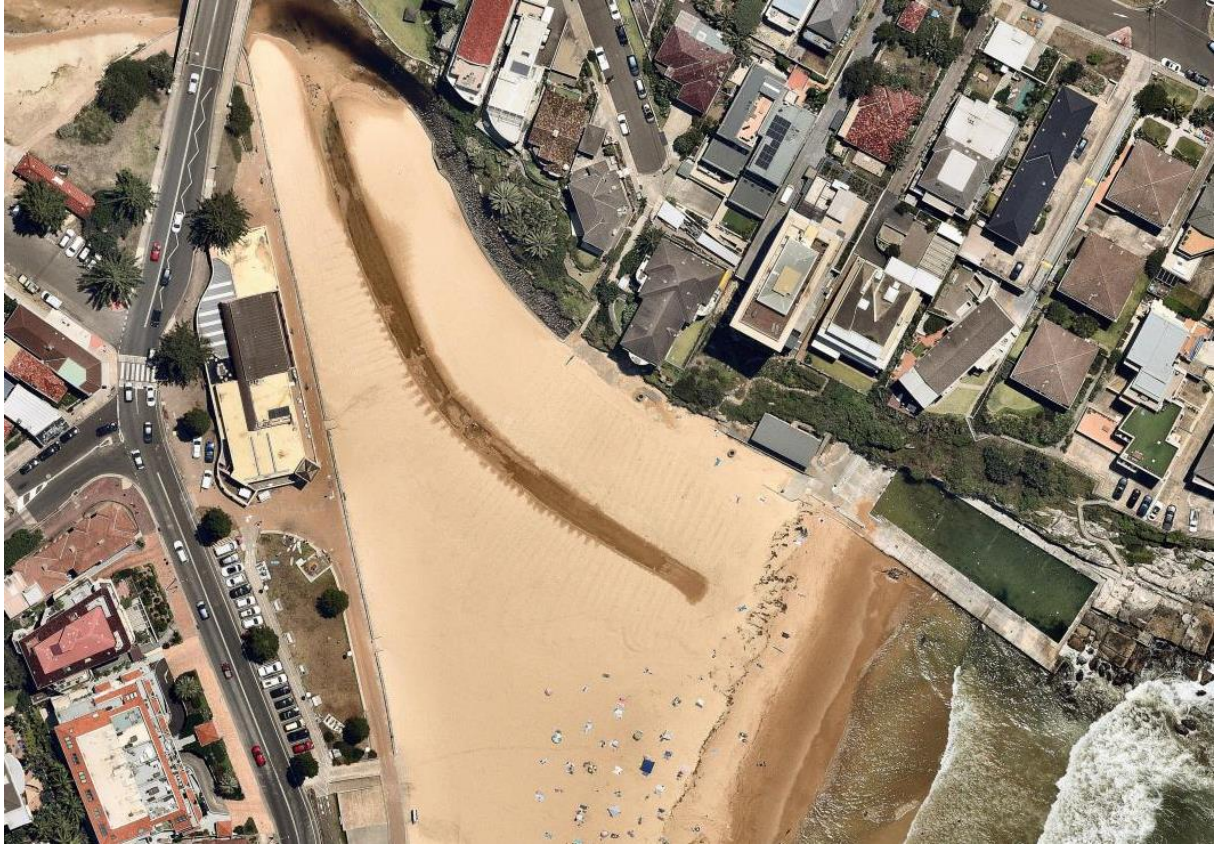
A.16: Channel across the beach used for flood mitigation (21/01/2021) (source: Nearmap)

Within the natural connection, Northern Beaches Council maintains the “Scour Channel” as per councils Lagoon Operational Management System (internal document) along the beach that can be broken out in the event of a flood (Lyons and Eggleton, 2013; Harrison and Rayner, 2019). The protocol for opening of the lagoon is now determined using the Manly “LagoonWatch” system (Lyons and Eggleton, 2013). This system incorporates data gathered from lagoon water levels with rainfall and flood predictions to determine the optimal time to open the lagoon. This generally occurs when the water levels in the lagoon are between 1.0 and 1.4 m AHD and there is a difference between the lagoon and ocean water levels greater than 0.6 m (Lyons and Eggleton, 2013).
